# Austin Tree-Canopy Resource, Phase II Project

## Austin Canopy and Water Quality

### Purpose and Objective

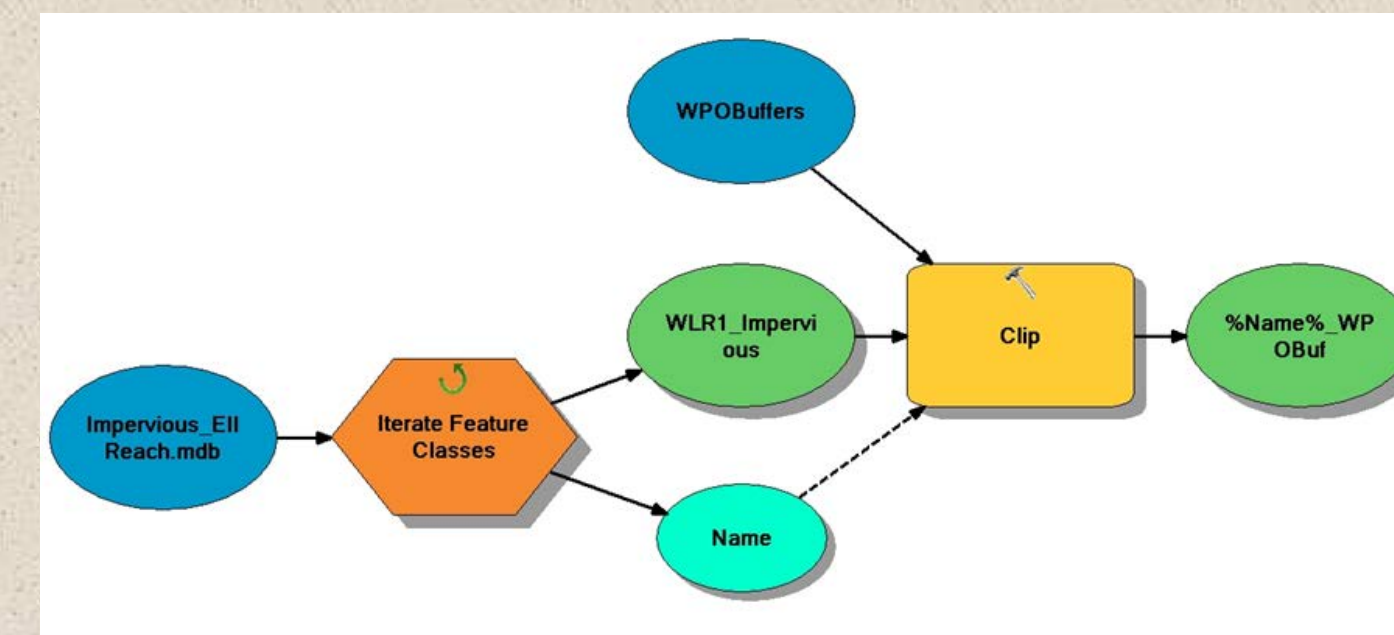
Figure I. Feature Class Clip Model

Next the team clipped the tree canopy, impervious cover, and creek line data to the remaining reaches and both buffers, refer to Figure I below. This allowed the team to find the area of canopy and impervious cover within the reach boundaries and buffers. With the areas ACWQ calculated percentages.
